WINTER 2009 NEWSLETTER FOR THE PEOPLE OF

Union Grove Lake

Deer Creek study to help target water quality efforts

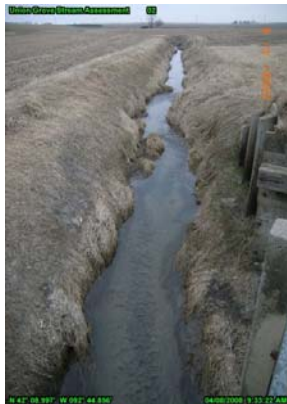
Deer Creek: main channel

It also showed segments along Deer Creek's main channel with numerous knickpoints, significant channel degradation, and severe streambank erosion. Upon looking at historical aerial photographs, these degraded stream segments also correspond with sections of Deer Creek which have undergone significant artificial channelization, both recently and decades ago.

Deer Creek's RASCAL revealed that nearly all of the 4.3 corridor miles studied would benefit from the installation of riparian grassed filters.

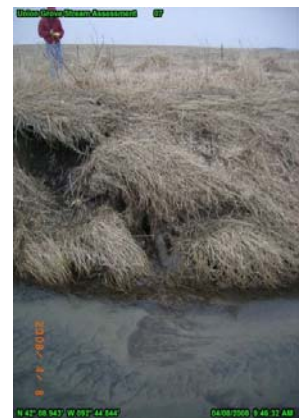
Straightening a stream may make the adjacent land more farmable, but it also shortens the overall length of the stream. This increases both the streambed slope and the flow velocity within the channel. As the overfalls continue to cut down into the streambed, adjoining streambanks erode, become unstable, and eventually slough into the stream.

Deer Creek: streambank sloughing
